# NEW RIVER BASIN

Name Of Dam: CRAB ORCHARD CREEK

Location: BLAND COUNTY

## PHASE I INSPECTION REPORT NATIONAL DAM SAFETY PROGRAM

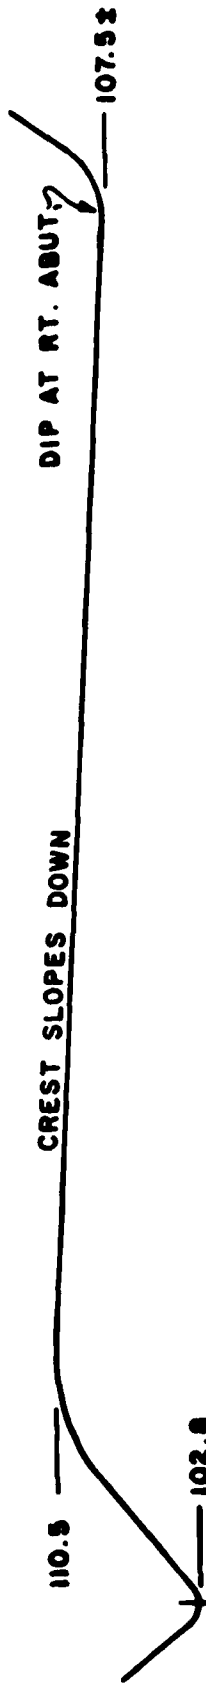
CRAB ORCHARD CREEK  
N.T.S.  
PLATE 2

There is one seep located at the base of the dam at the right abutment as shown on Plate II. The origin was not found because of vegetation and boulders inhibiting the inspection in the area. The owner representative said he had checked the spring monthly for the past two years and had noted no changes. Flow is clear. No estimate of the quantity was made. The source and age are unknown.
